G-V-D-011

INVENTORY FORM FOR STATE HISTORIC SITES SURVEY

William Povish Farm

Kempton Rd.-East side, .5 mile North of Kempton

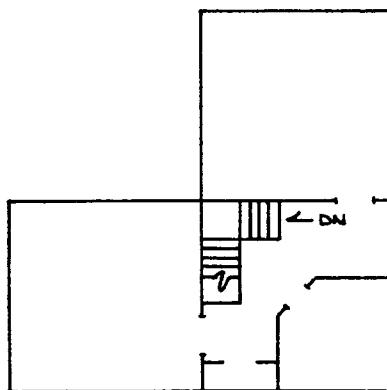
2ND FLOOR

The interior arrangement is a two room plan with a one room rear ell. The two front rooms, each with its own exterior entrance, have always been referred to by the original occupant as "the parlor" (northeast end) and "the drawing room" (southwest end). A two flight stairway is located against the partition wall in the drawing room. Ten stairs rise to a landing, then four additional stairs rise to the right. The newel post is square with applied moldings, and square balusters are spaced two per tread. The second floor contains three bedrooms corresponding generally to the same layout as the ground floor. The area above the drawing room, however, contains a hallway and a built-in closet with hand planed paneled doors as well as a five-sided corner bedroom. Window surrounds, door surrounds and baseboards throughout the house are plain, flat board. The interior doors are five-paneled with white ceramic knobs.

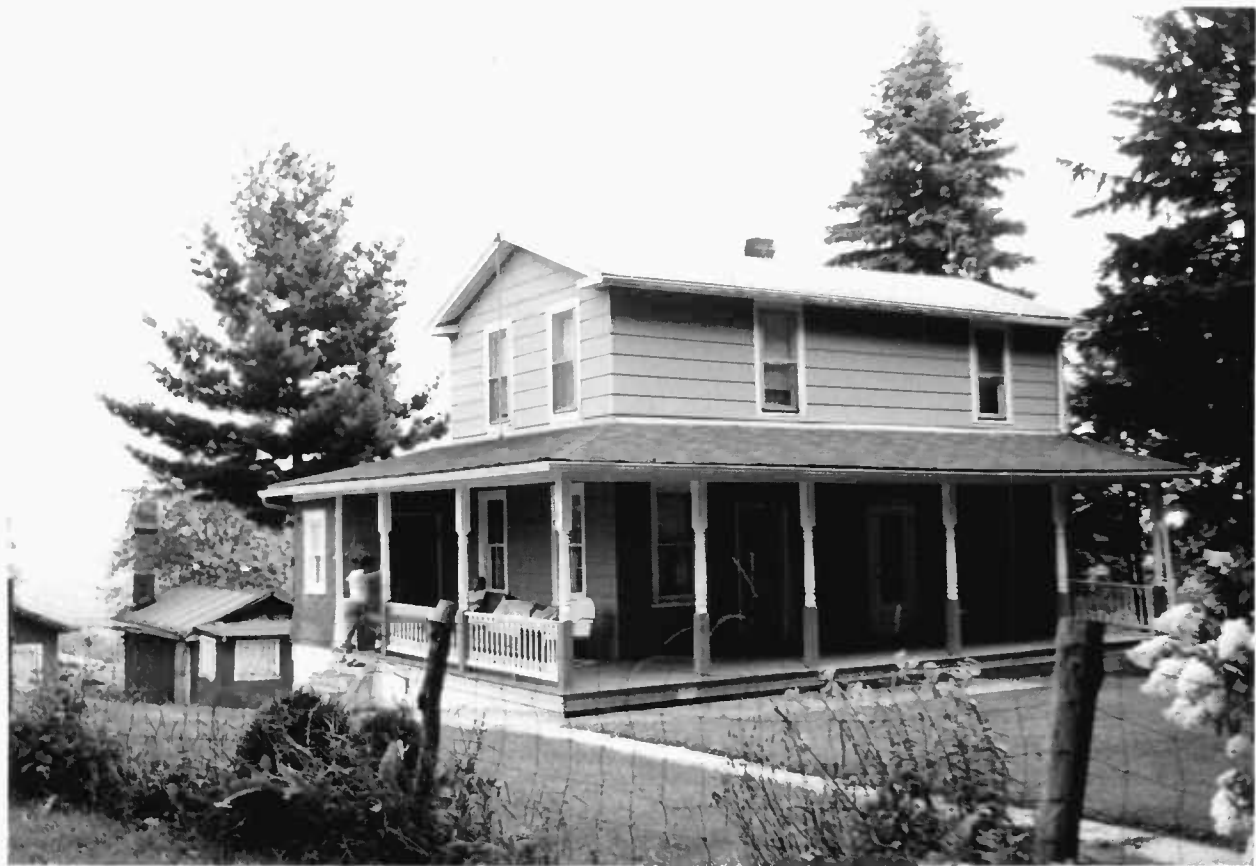
NW elev.

The house is a two story, frame structure built ca. 1910. Its basic configuration is an ell-plan with a shallowly pitched gable roof and an irregularly spaced four bay facade with two central doors. A shed-roofed porch extends the full length of the facade, covers the northeast endwall, and then continues to the rear ell as an enclosed room.

The exterior walls are covered with narrow German siding which has slightly uneven beveled edges. This suggests that these boards may have been hand planed into German siding from standard weatherboard. Recently, however, the house has been covered with gold aluminum siding and the only place where the original siding is visible is within the enclosed area of the porch.

One over one sash windows with plain board surrounds and narrow sills light the building. The roof, which is covered with asphalt shingles, has a shallow box cornice with partial gable end returns. A brick chimney is located along the ridgeline of the rear wing.

The porch rests on a cement block foundation and is supported by eight turned posts with a turned baluster railing at the northeast and southwest ends. The enclosed section of the porch is covered with green hexagonal asphalt shingles and has three over one sash windows.
